RUINS STABILIZATION REPORT
TECHNICAL SERIES NO. 25

HISTORICAL DOCUMENTATION
AND STRUCTURAL STABILIZATION
OF THE MAIN FERRY SITE
LEE'S FERRY NATIONAL HISTORIC DISTRICT
GLEN CANYON NATIONAL RECREATION AREA
NORTHEASTERN ARIZONA

1987

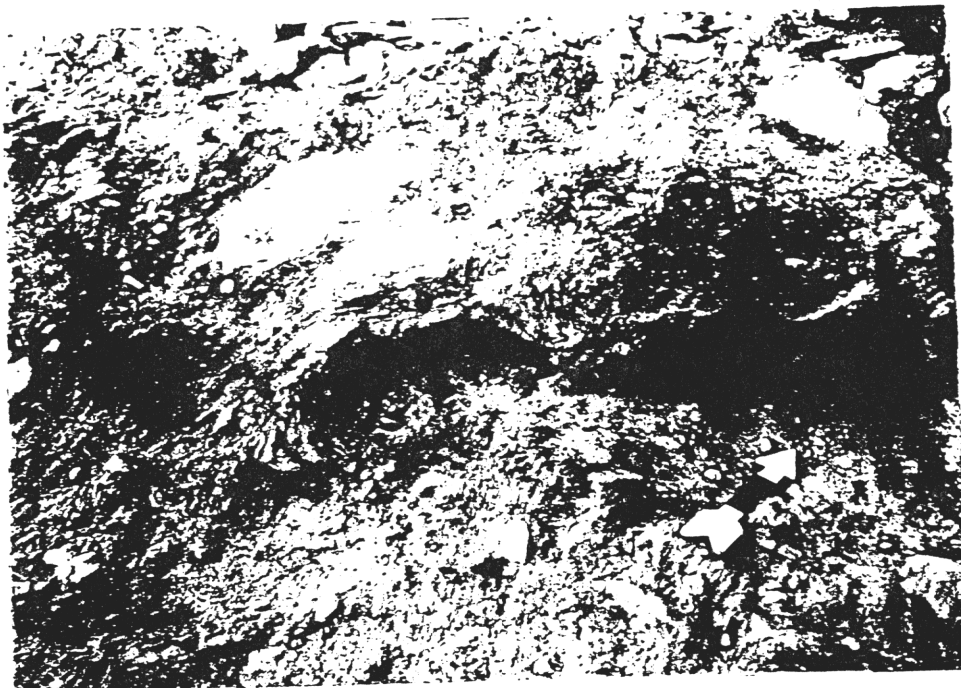
Figure 10. South wall of Structure 2, after removal of intrusive rock wall. Note burned layer (right), probably cut through by previous stabilizers to place rocks, and charred end of upright post (left).

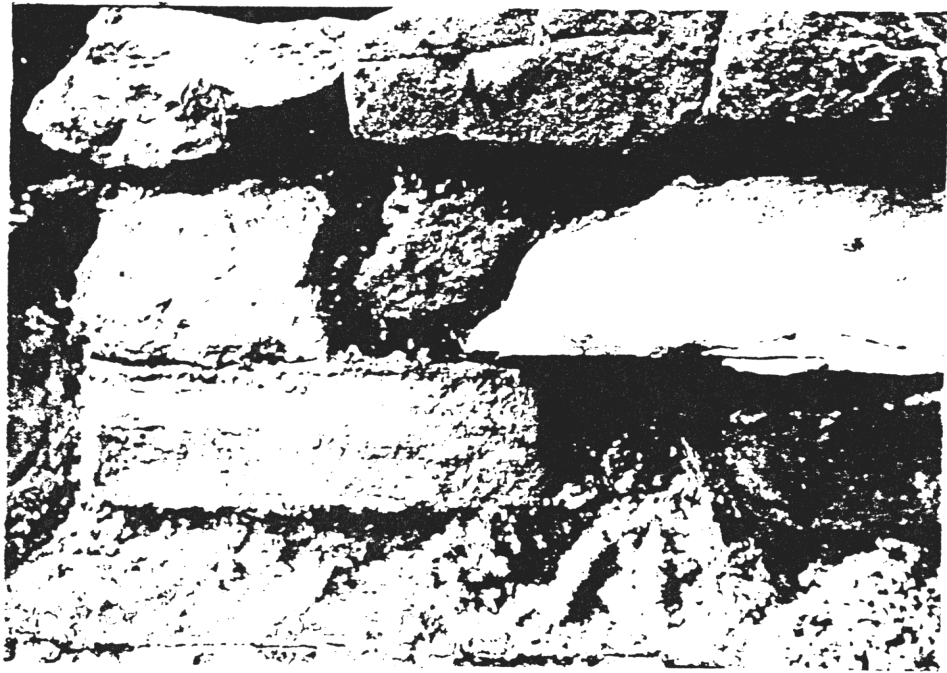
Figure 24. Structure 2, north fireplace; caliche accumulation on stabilization mortar surface during drying.

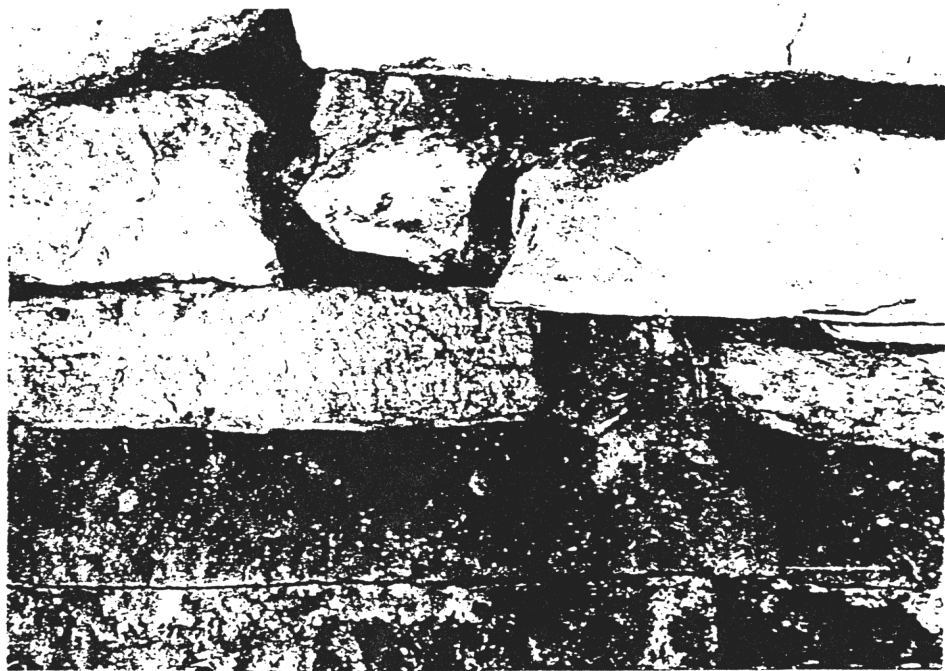
Figure 25. Structure 2, north fireplace; after spraying and brushing for caliche removal.

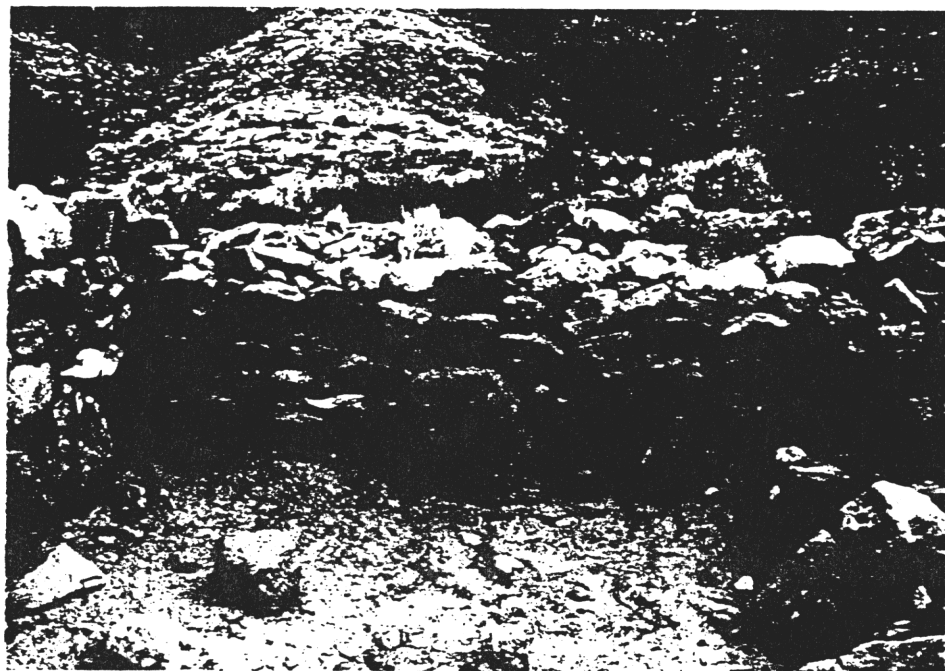
Figure 27. Interior north wall of Structure 1, before stabilization and removal of previous stabilization mortar. Note basal erosion and partly unsupported stones.

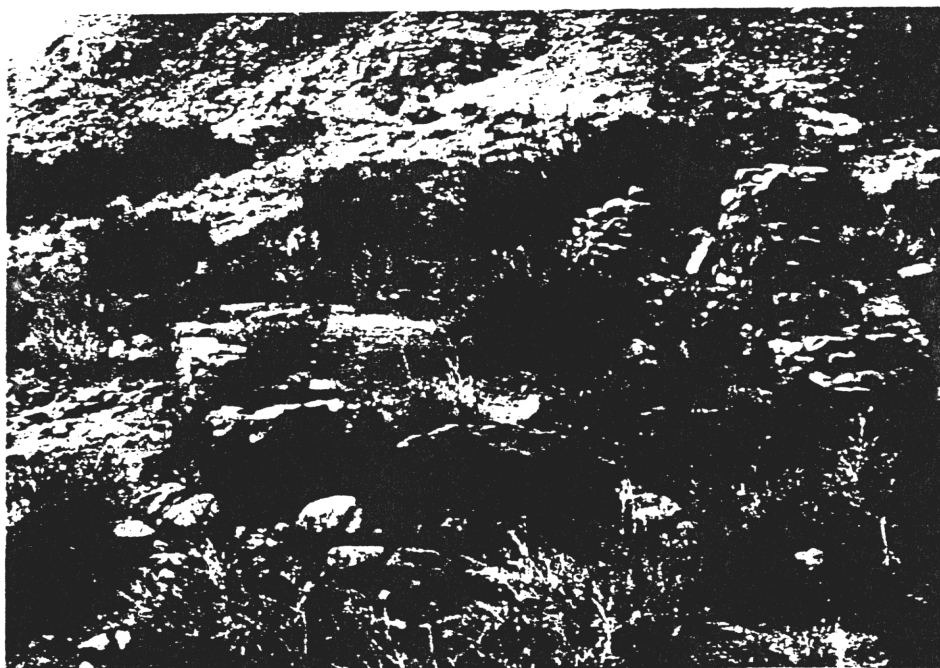
Figure 28. Overview of Structure 2, before stabilization and removal of previous stabilization mortar.

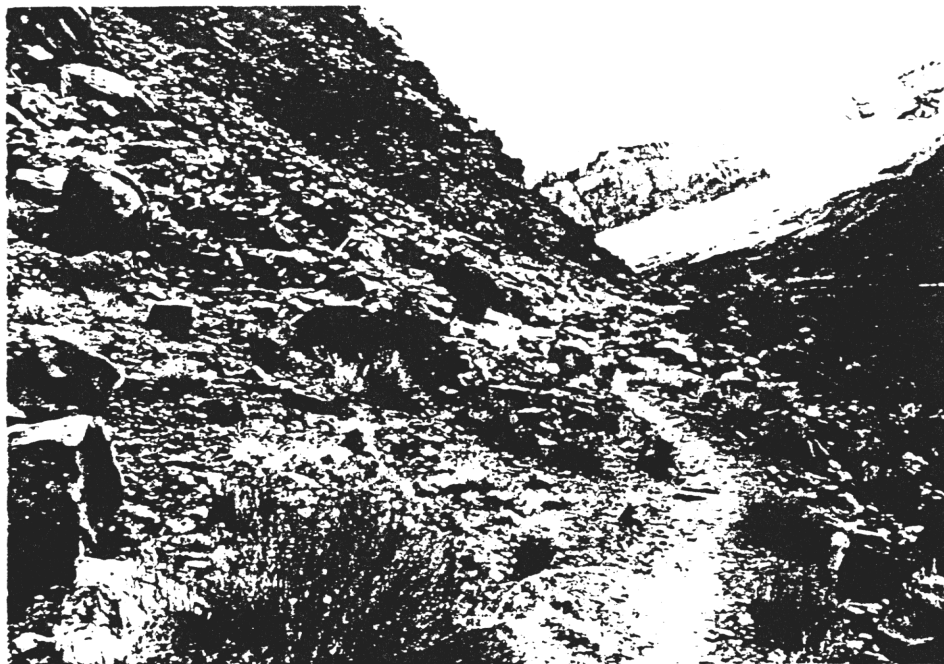
Figure 30. Overview of Structure 4, before stabilization. The foot trail runs through the center of the structure.

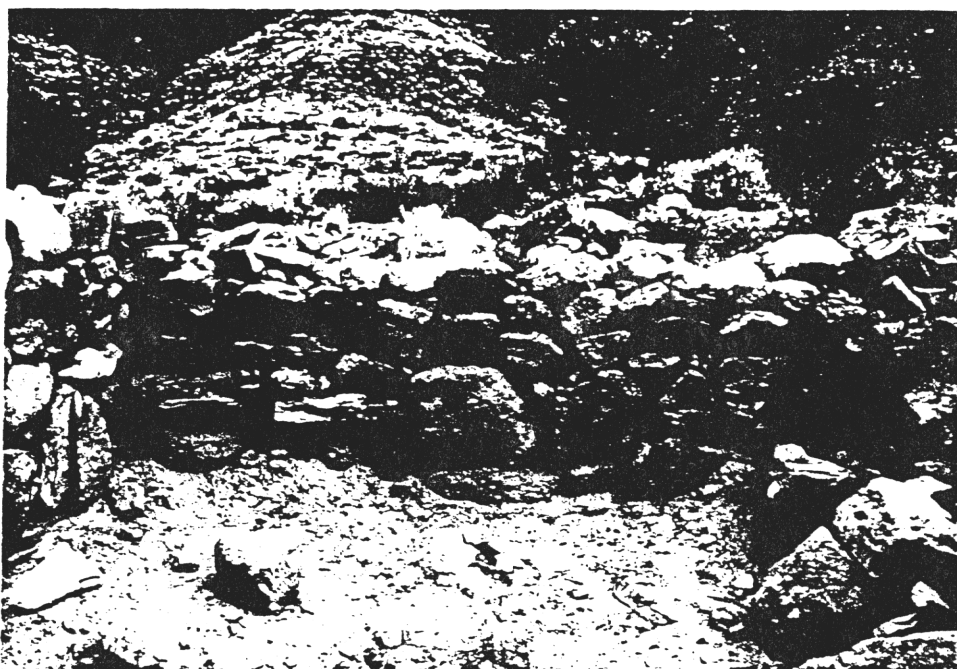
Structure 1, north wall interior before stabilization.

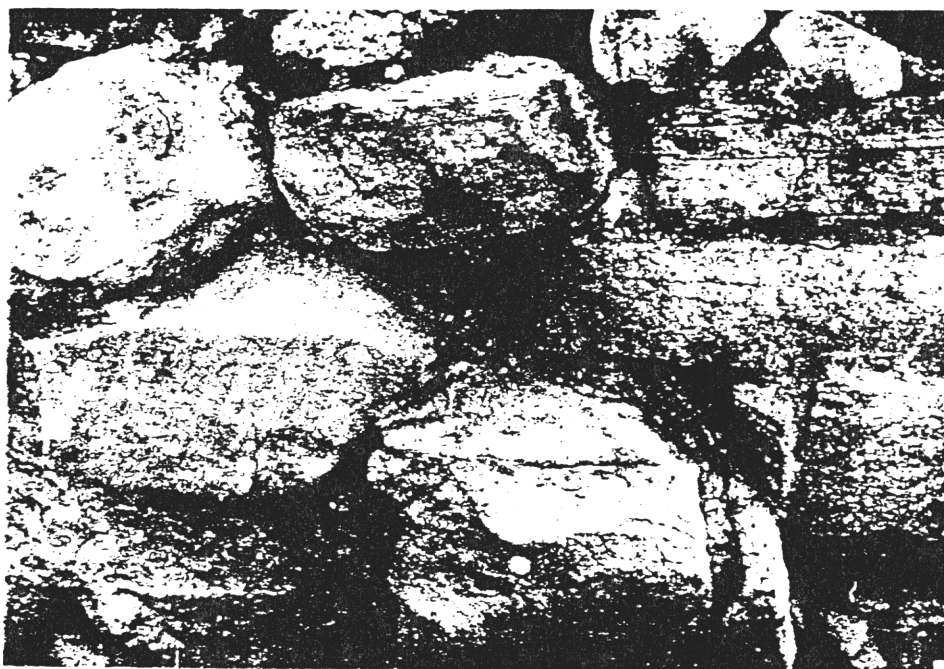
Structure 1, north wall exterior showing previous stabilization mortar.

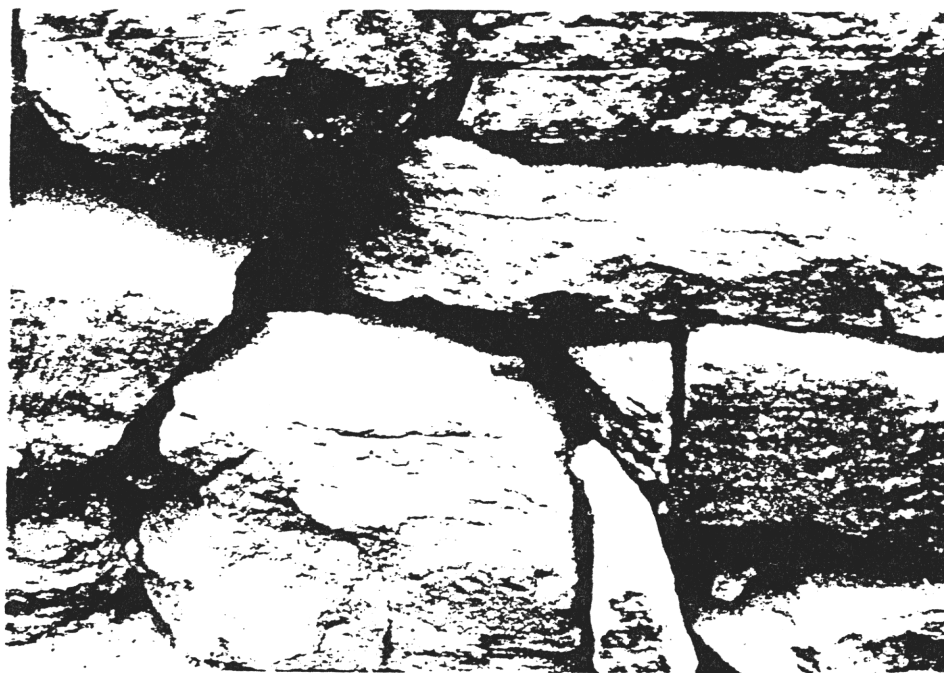
Structure 1, north wall exterior after removal of previous stabilization mortar.

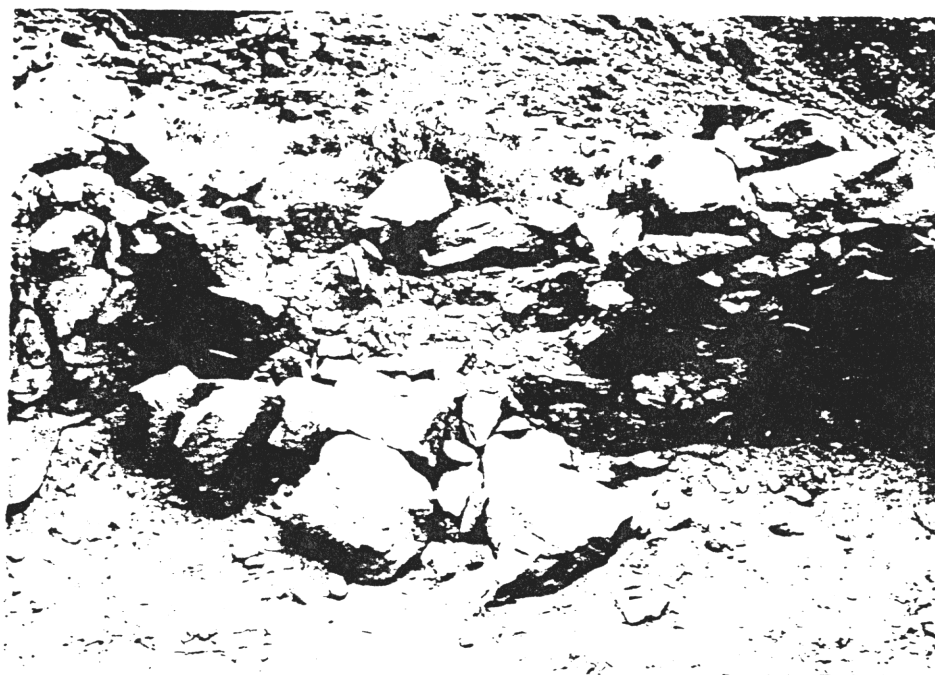
Structure 1, east wall interior before stabilization.

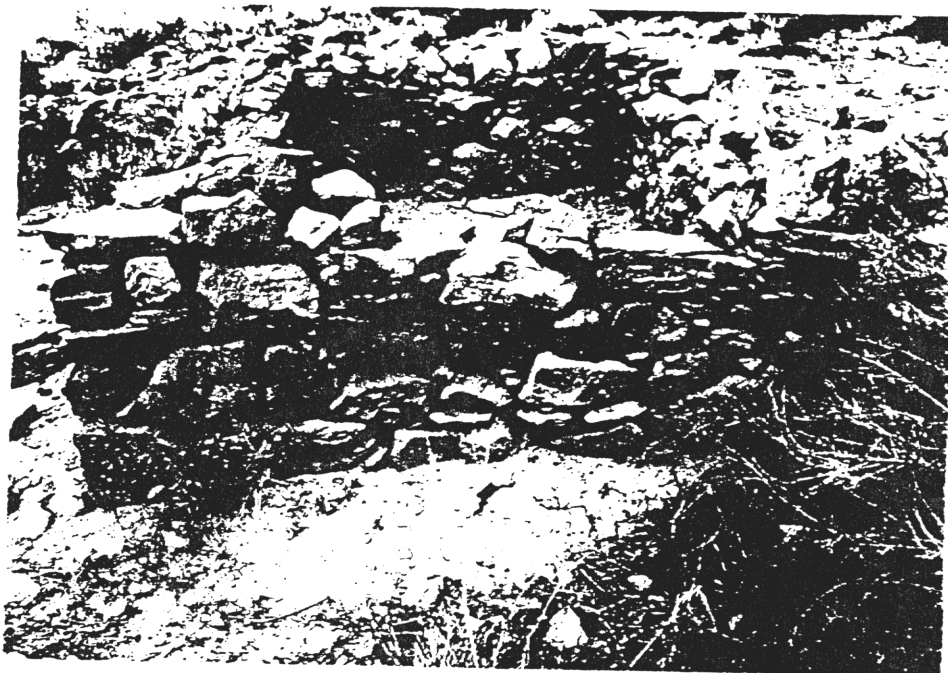
Structure 1, east wall exterior before stabilization.

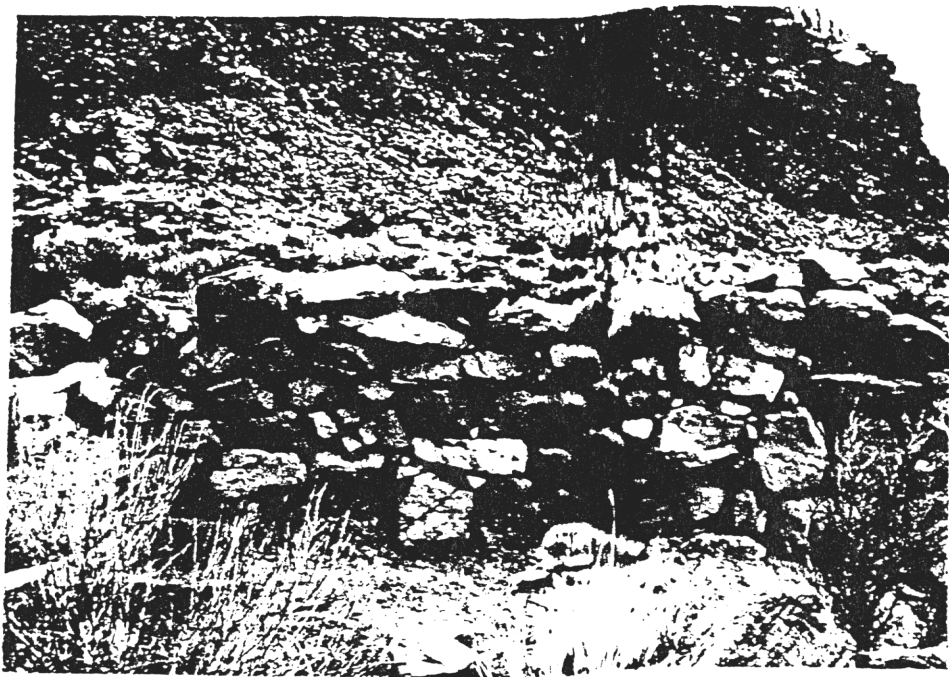
Structure 1, west wall exterior before stabilization.

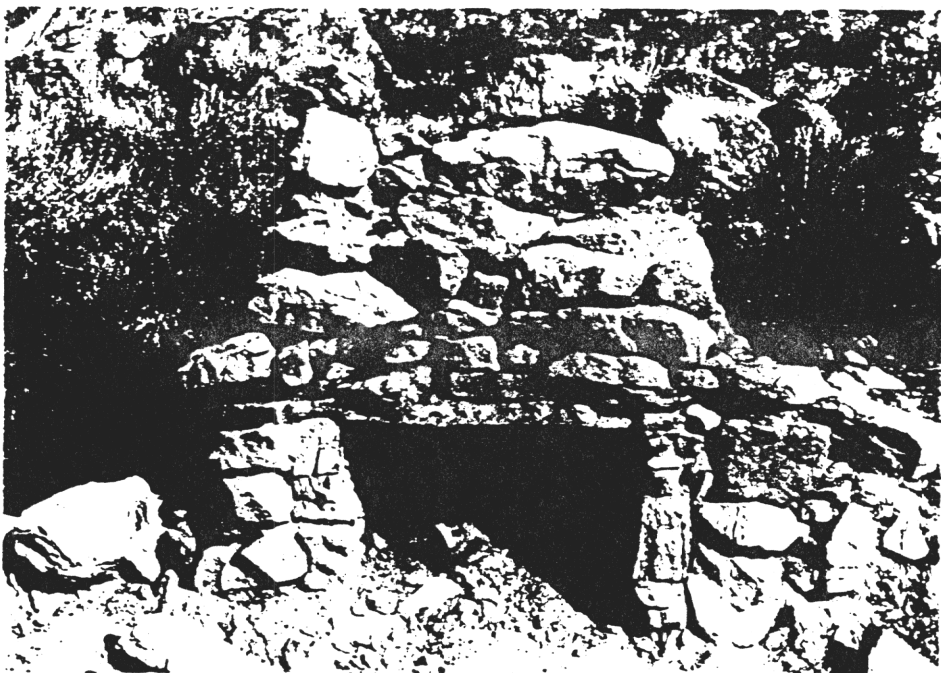
Structure 2, east interior, north fireplace after removal of previous stabilization mortar.

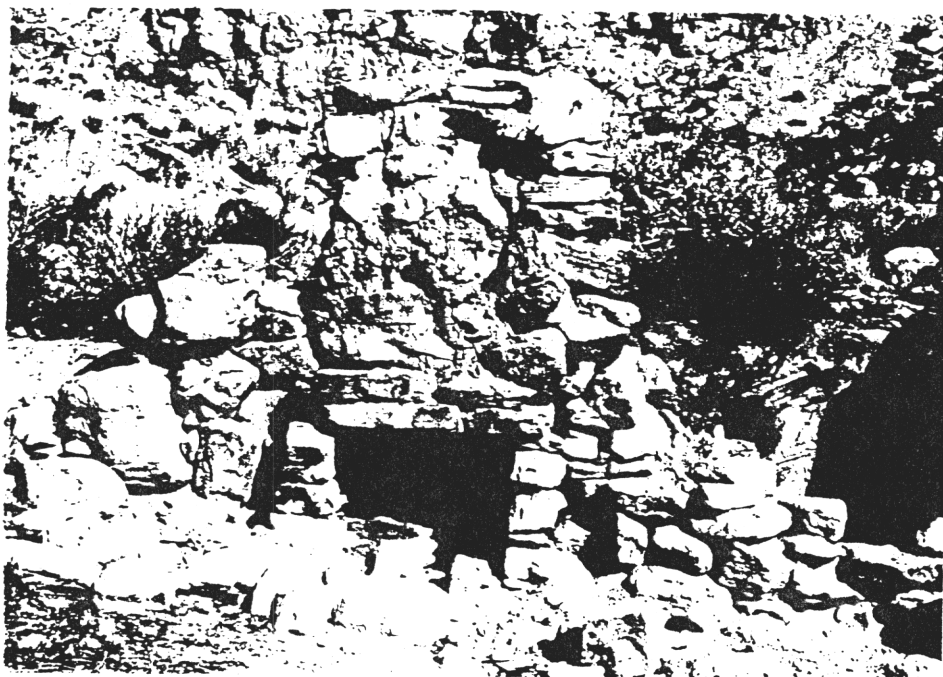
Structure 2, east interior, south fireplace after removal
of previous stabilization mortar.

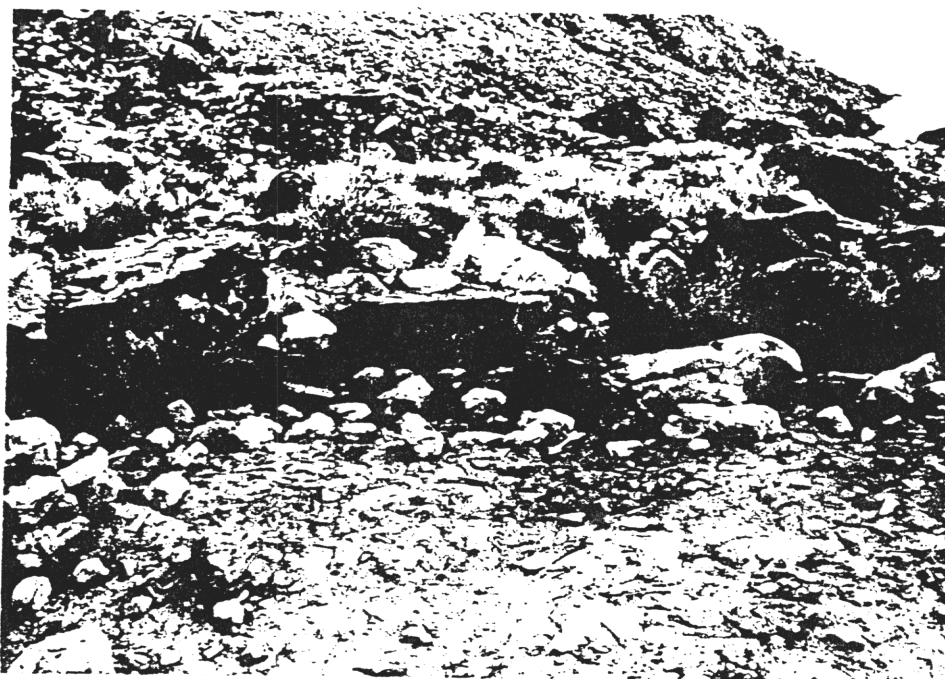
Structure 2, south interior after removal of previous reconstruction work.

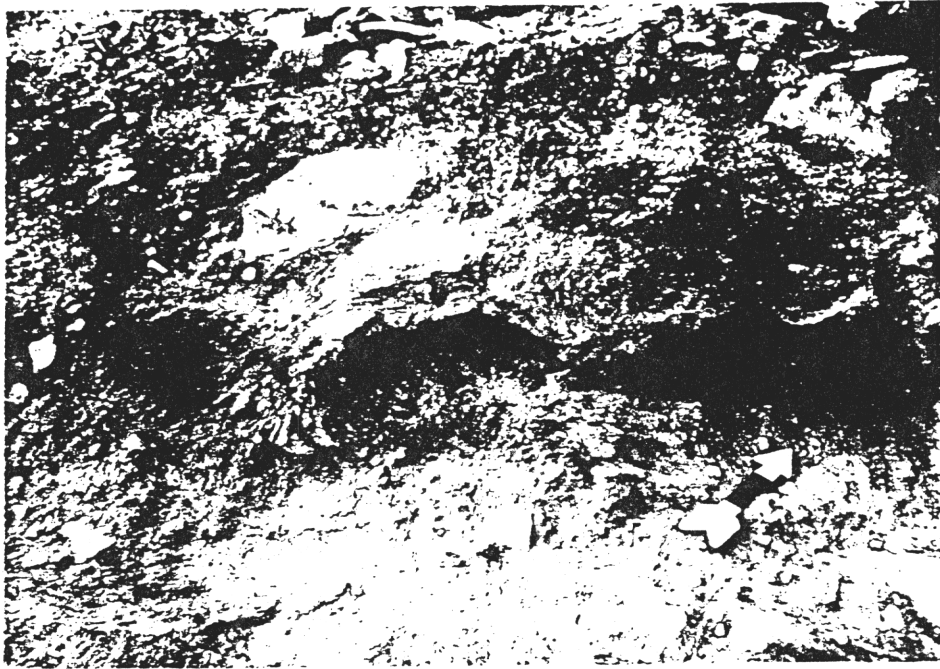
Structure 2, south interior, showing charcoal stain under the reconstructed wall.

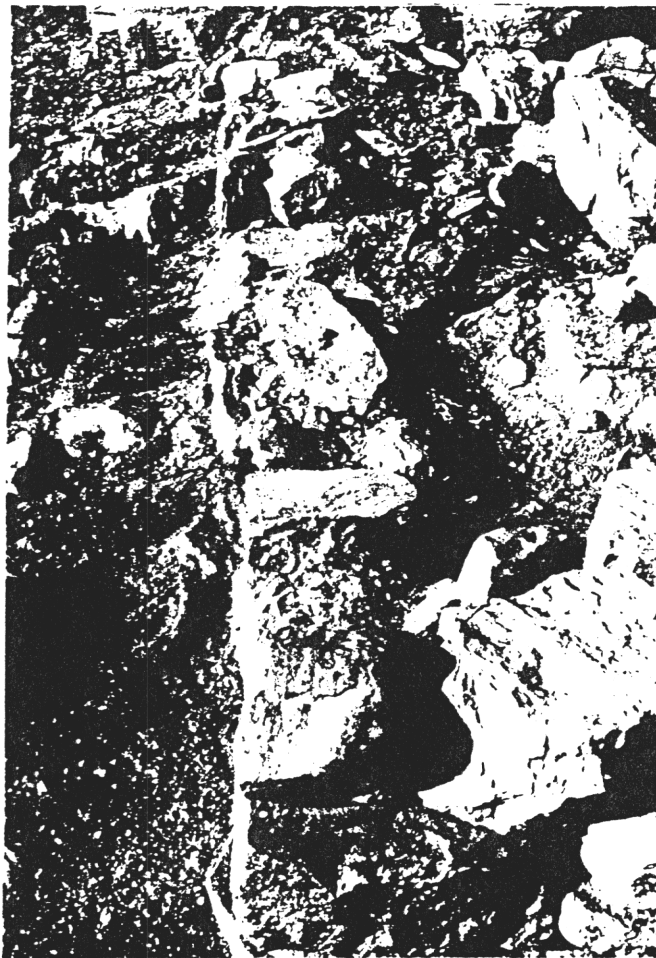
Structure 2, west wall showing charcoal stain under previous reconstruction work.

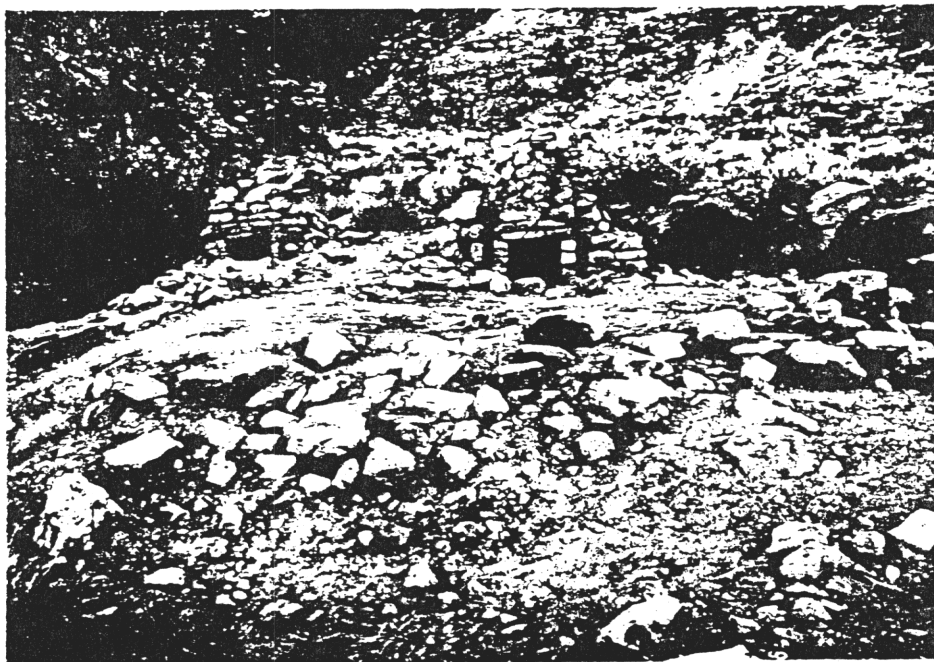
Structure 2, after location of west wall was backfilled.

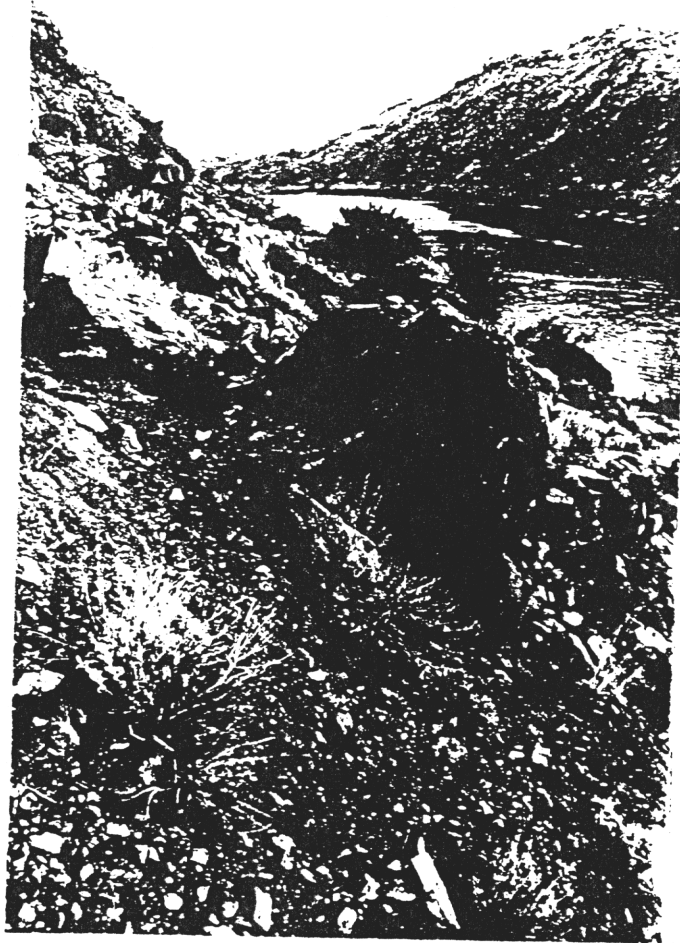
Structure 4, northeast exterior, after
drainage contouring.
